TP 185E
Issue 2/2012

AVIATION SAFETY LETTER

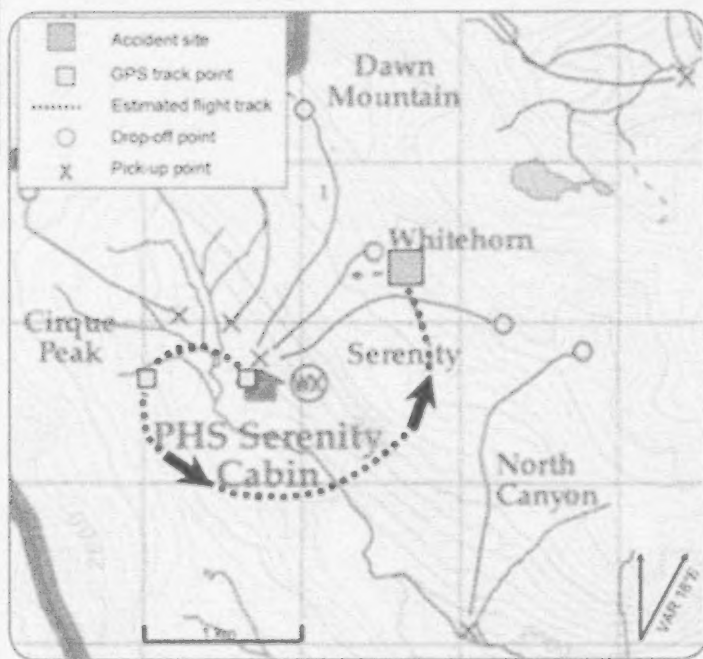
Helicopter flight path

The helicopter's forward and vertical speeds were very low when it contacted terrain, consistent with a normal landing. The helicopter did not slide forward after the skids contacted the snow; it remained upright and oriented in the direction it had been travelling. The low vertical and forward speeds at touchdown are consistent with the pilot intentionally landing the helicopter at the accident site. It is possible that, due to a lack of visual references and to blowing snow from the rotor downwash, the pilot was unaware that the helicopter was close enough for the rotor blades to strike the mountainside.

Wind direction had remained steadily uphill (approximately 90° to the flight path) for several hours prior to the accident, but wind and gust speeds had

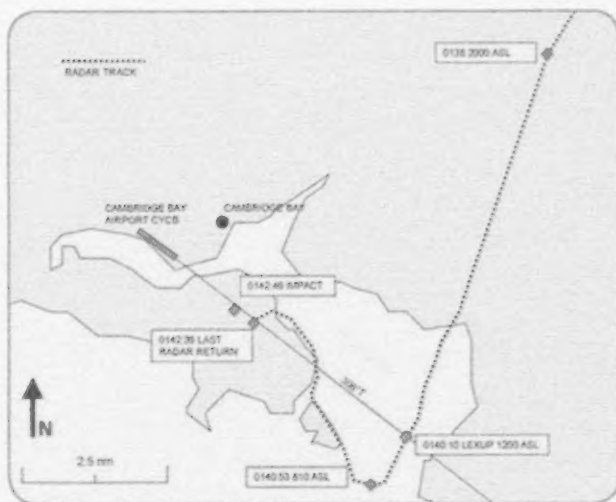
Radar plot of the occurrence aircraft.
(The grey area represents land and the white area represents water.)

On December 13, 2008, a Dornier 228-202 was on a charter flight from Resolute Bay to Cambridge Bay, Nun., under instrument flight rules (IFR). While on final approach to Runway 31 True, the aircraft collided with the ground approximately 1.5 NM from the threshold at 01:43 MST. Of the 2 pilots and 12 passengers on board, 2 persons received serious injuries. The aircraft was substantially damaged. The ELT activated, and the crew notified the Cambridge Bay Airport radio operator of the accident via the aircraft radio. Local ground search efforts found the aircraft within 30 min and all occupants were removed from the site within 2 hr.

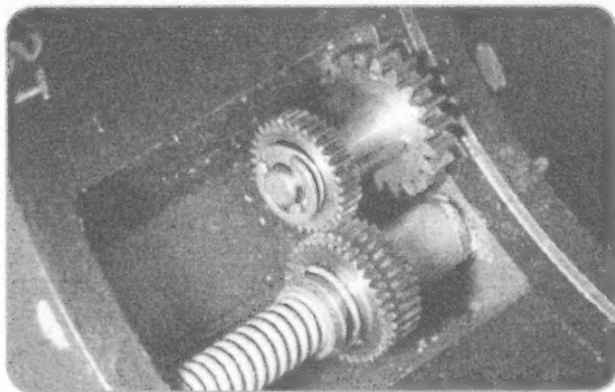
*Barometric pressure/pointer setting gears.
The gear on the right had teeth damage.*

During the flights from Yellowknife, Cambridge Bay, and Resolute Bay, there was a difference in readings between the two altimeters installed in the aircraft. The pilots recognized this discrepancy and compensated by setting the first officer's instrument to match the altitude reading on the captain's altimeter. The crew did not determine that the captain's altimeter was in error, although it would have been possible to determine which instrument was faulty by comparing altitude readings on the ground at known altitudes. Because altitude was not monitored in relation to aircraft position in the late stages of the approach at Cambridge Bay, it is unlikely that this error played a significant part in the occurrence. There was no company SOP to detect altimeter errors.

An erratic altimeter barometric setting knob could be a symptom of internal gearing deterioration, which can result in loss of calibration. Because the only reference to this problem is found in the altimeter Component Maintenance Instruction Manual, which is not normally accessible to operator maintenance organizations, it is possible that an aircraft would be allowed to operate with a defective instrument with potential for calibration errors. Slippage of damaged gears could result in inaccurate readings.

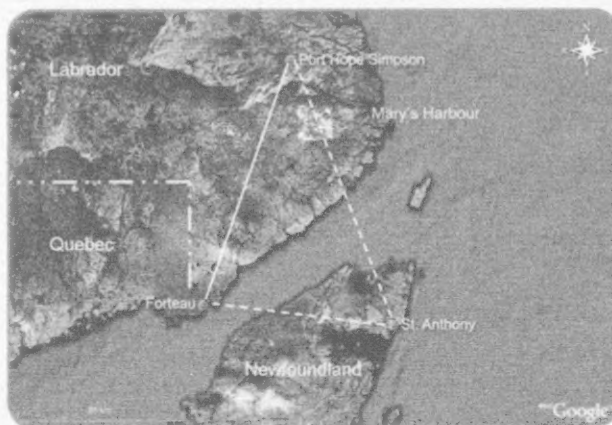
Route map

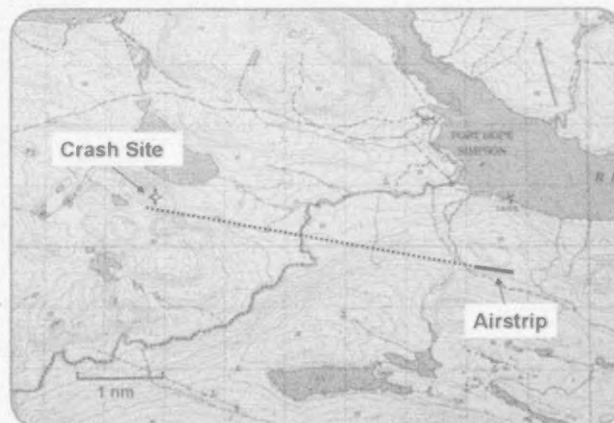
Location of the crash site relative to the airstrip

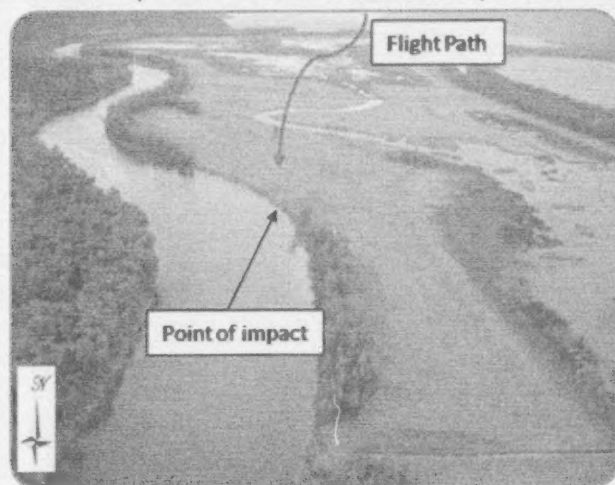
Accident flight path

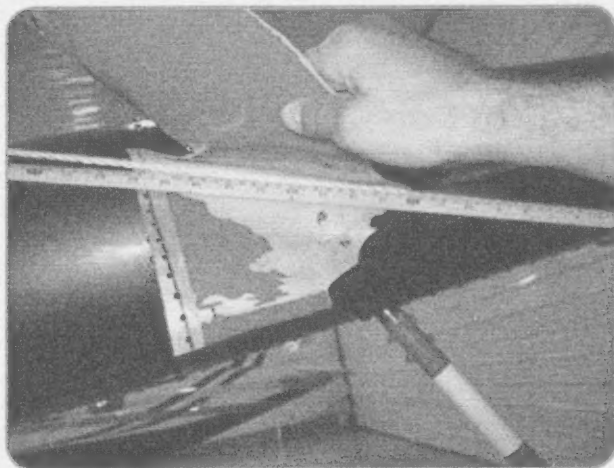
Tailboom rotor blade strike

It is conceivable that the student pilot encountered a bird during his steep-turn practice. During his attempt to avoid it, he may have applied control inputs that led to excessive main rotor flapping and mast bumping. Had he also lowered the collective, pushed the nose forward, or both, he would have been even more greatly exposed to the large aerodynamic forces that cause mast bumping. Such reactive manoeuvring is instinctive and often rapid, and in conjunction with the control inputs and in-flight attitudes often seen in steep-turn manoeuvres, is likely to cause rotor path plane upset and reduced clearance from the tailboom. Such flight conditions make mast bumping almost inevitable. In-flight mast bumping is frequently

irrecoverable and catastrophic, with either the mast being severed or a blade strike to the fuselage. In either case, the result is invariably fatal.

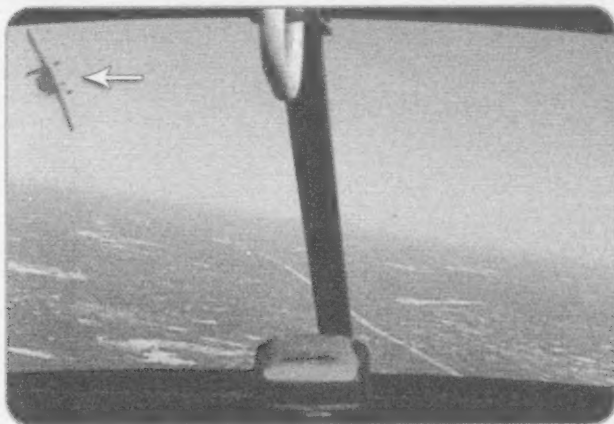
Video still image of the lead aircraft manoeuvring

A video camera had been mounted behind and slightly over the starboard passenger seat of the RV-7A. It was positioned facing forward, looking out through the windscreen. The entire occurrence flight was recorded. The video showed that after takeoff, the RV-7A had maintained a formation position behind the other two aircraft.

position with the lead. Near Wolfe Lake, the lead began a series of manoeuvres. The RV-7A chased the lead through the manoeuvres and, at times, the lead could be seen within view of the recording video camera. During this type of manoeuvre, the pursuing aircraft must turn at a higher rate or g in order to maintain the lead within the field of view of the video camera.

During a pull-out from a rapid descent, there was a sudden onset of an airframe vibration (shuddering around the longitudinal axis), which was followed by a yawing motion, a roll and ground impact.

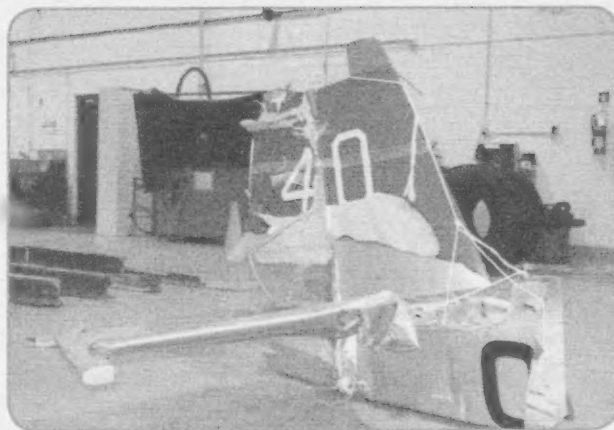
*Picture of re-assembled tail section during the investigation.
Pictures of the failed rudder are included in the
TSB Final Report*

The aircraft struck terrain at approximately 80° nose down, flipped over and came to rest upside down. The aircraft was destroyed from impact forces and there was no post-impact fire. Damage to the aircraft was consistent with severe impact forces. The vertical stabilizer and top half of the rudder were missing from the aircraft and could not be located at the wreckage site. After an extensive ground search, the vertical stabilizer and rudder were found approximately 0.6 NM southeast of the main wreckage site. The vertical stabilizer was intact. A portion of the rudder was attached to the vertical stabilizer. Numerous parts of the rudder, including the right aluminum skin and rudder trailing edge wedge, had separated from the main rudder structure and were located within 100 m of the vertical stabilizer. The rudder counterweight could not be found. The vertical stabilizer had completely separated from the fuselage. The fractures in the vertical spars occurred just above where the spars fastened to the fuselage. The fracture surfaces were consistent with failure by overstress.

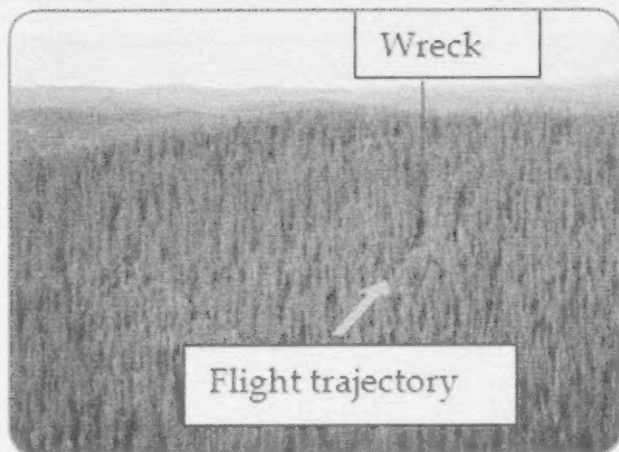
Flight trajectory and position of the wreck on the side of the mountain

The aircraft hit the side of a mountain at approximately 100 ft from the peak during level flight, in adverse weather conditions. The TSB analysis focuses on the decision to carry out this VFR flight in bad weather, and on the survival of the occupants.

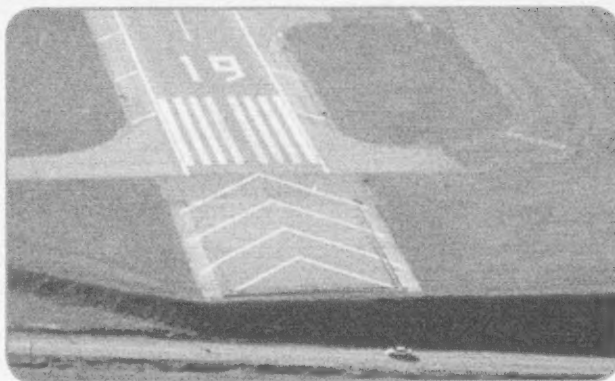
Photograph of an EMAS installation. (The EMAS bed is the grey area under the yellow chevrons) Ref: TC AIM AGA 9.1
